NO NAME 880 DAM
PIKE COUNTY, MISSOURI
MO 31011

PHASE I INSPECTION REPORT NATIONAL DAM SAFETY PROGRAM

SUBJECT: No Name 880 Dam, MO ID No. 31011

Name of Dam: No Name 880 Dam
State Located: Missouri
County Located: Pike County
Stream: Mud Creek
Date of Inspection: 29 September 1978

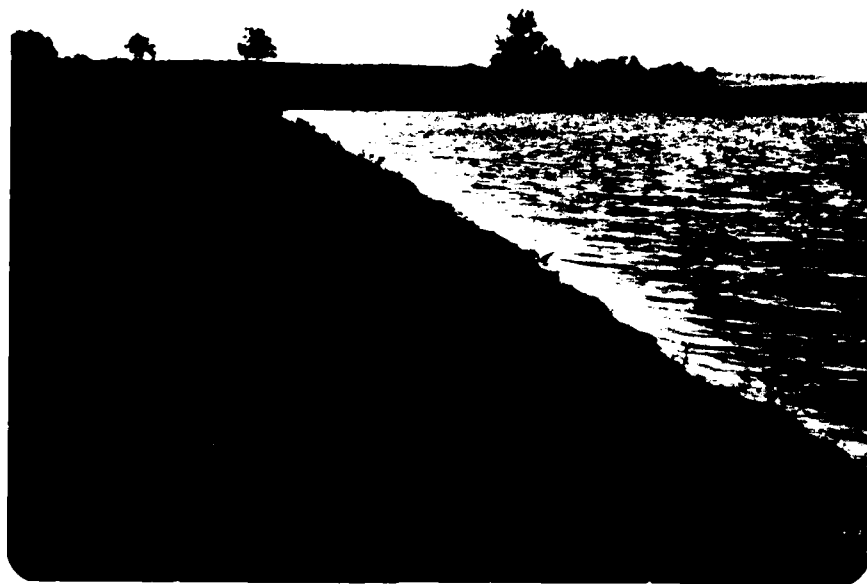
The horizontal alignment was good. A depression in the embankment was noted near the south end of the dam. No surface cracking or unusual movement was observed. The absence of riprap has allowed some erosion of the upstream face of the dam.

Upstream Face of Embankment - Looking South

Minor erosion noted at the contact of the south abutment, if left uncontrolled or uncorrected, could lead to serious problems in the future. Wave protection should be provided for the upstream face of the dam.
